**United States Environmental Protection Agency
Region III
Waste & Chemicals Management Division
RCRA Compliance & Enforcement Branch
Wheeling Office**

Narrative Subtitle I Inspection Report

On October 20, 2003, EPA Waste & Chemicals Management Division conducted an underground storage tank ("UST") inspection of the Dairy Mart #6 located at 1205 Dorsey Avenue in Morgantown, West Virginia. The facility is identified by West Virginia ID# 3103960. The purpose of this inspection was to determine the facility's compliance under Subtitle I of the Resource Conservation & Recovery Act ("RCRA"). All information included in this report are the results of statements by the facility representatives, materials shown to the inspector by facility representatives during and subsequent to the inspection, and a review of EPA and state records.

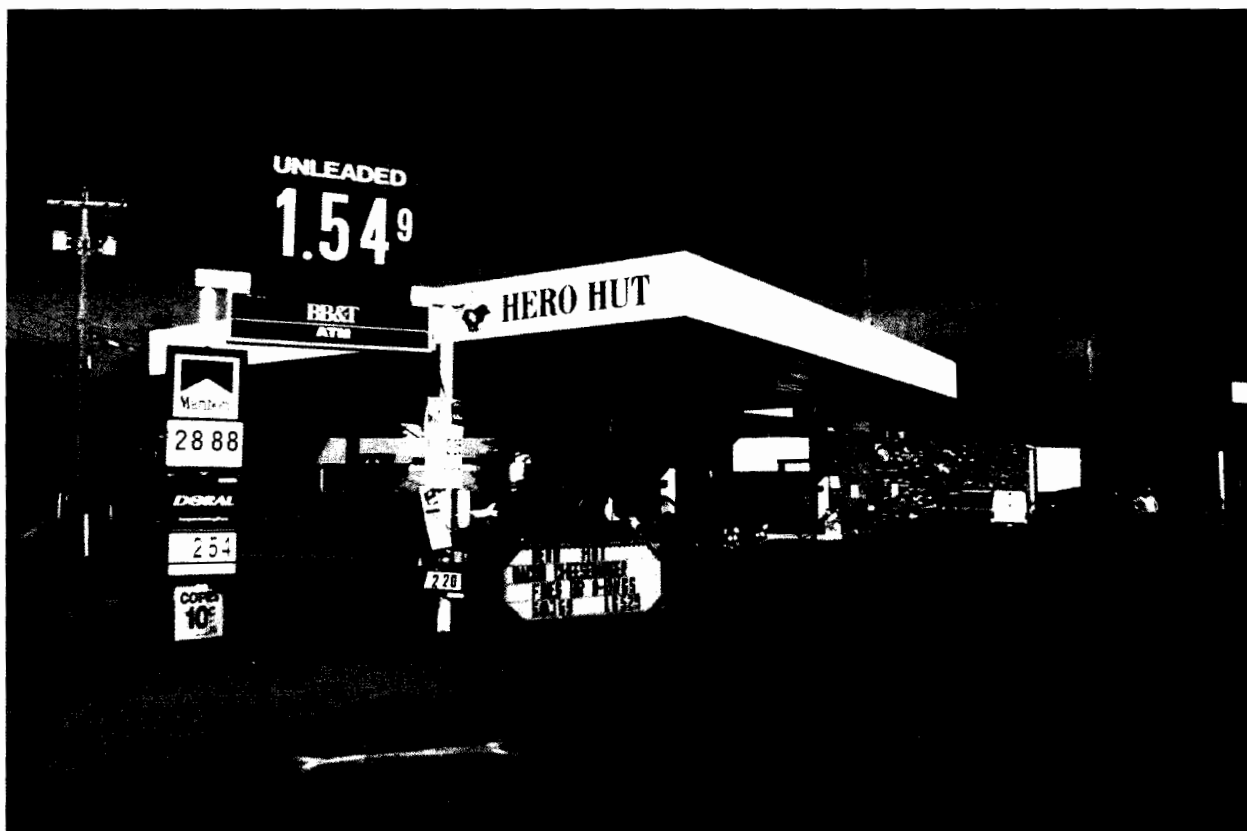
Dairy Mart #6
Morgantown, WV
ID #3-103960
Inspected: October 20, 2003
Inspector: Clark S. Conover
EPA/RIII/Wheeling
Photo#: 1

This photo depicts the station.

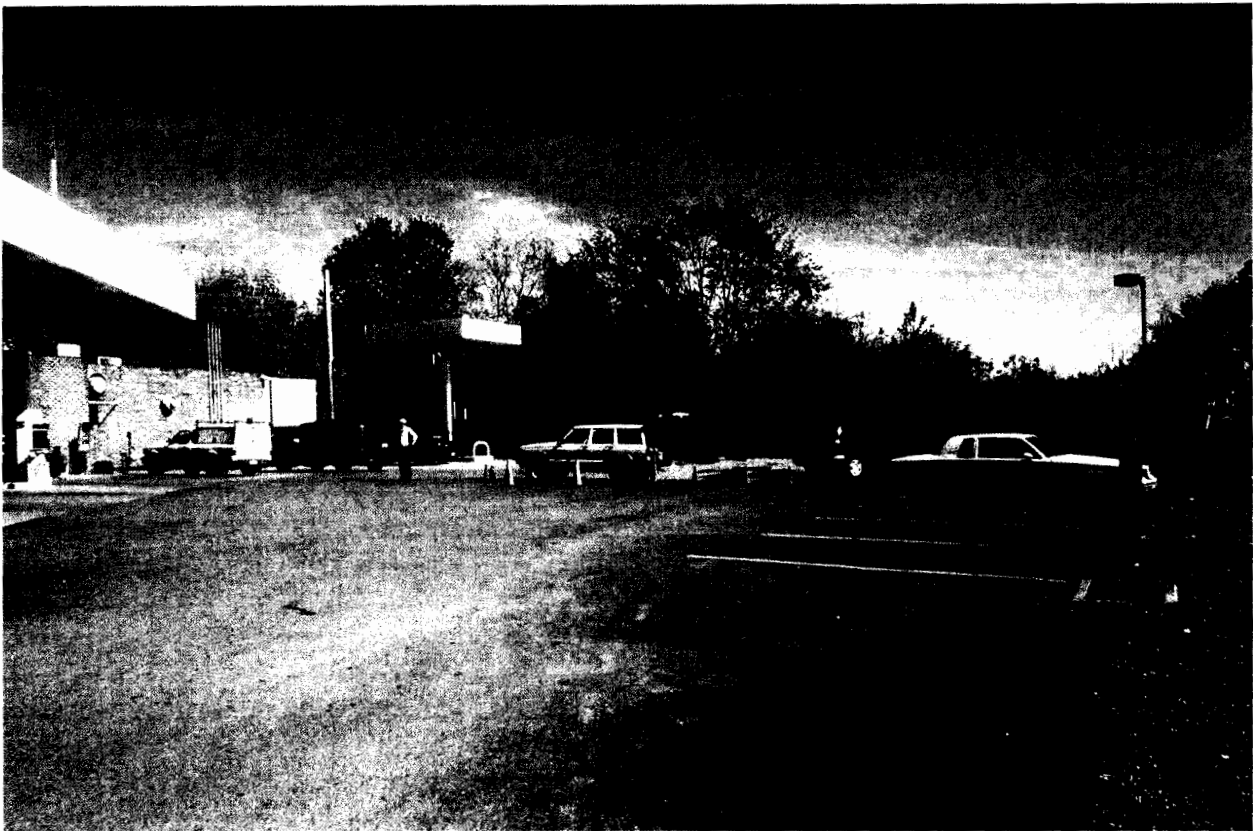
Dairy Mart #6
Morgantown, WV
ID #3-103960
Inspected: October 20, 2003
Inspector: Clark S. Conover
EPA/RIII/Wheeling
Photo#: 2

This photo depicts the station with the tank access points in the background.

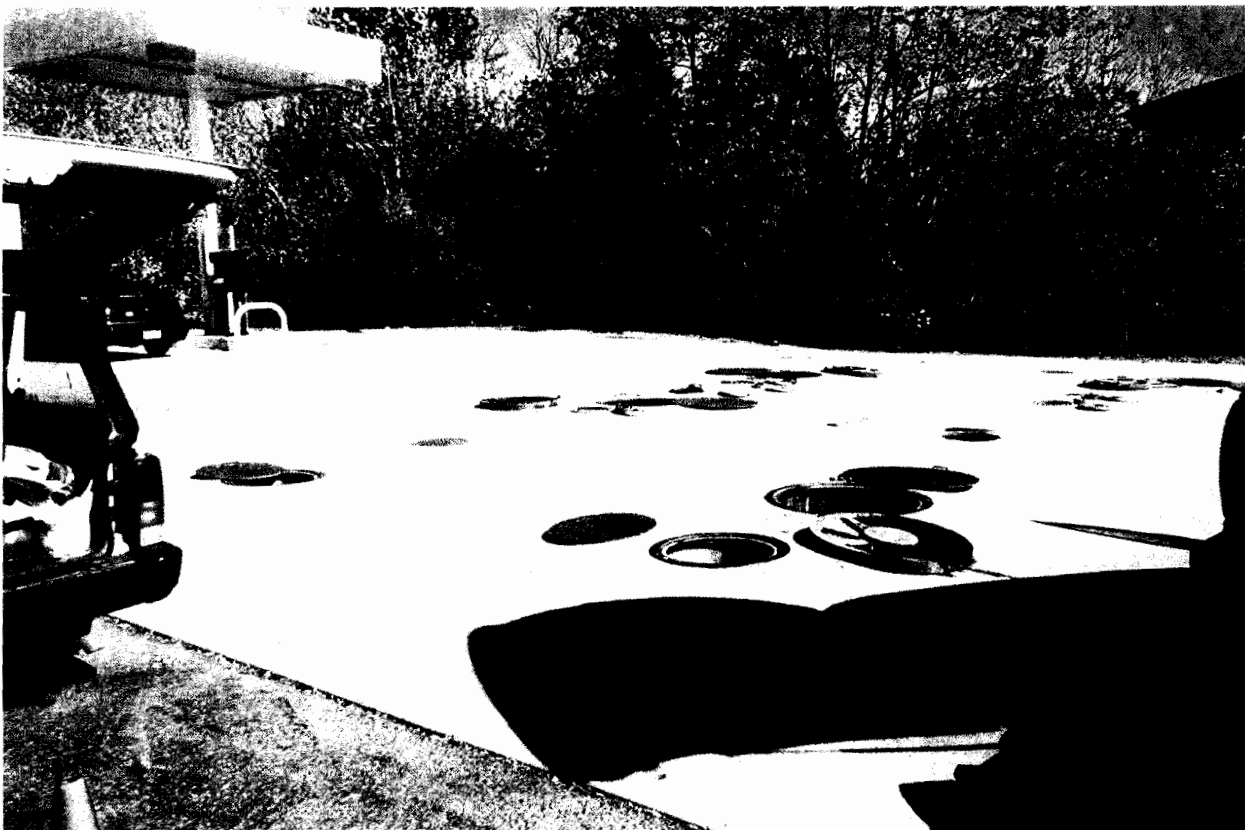
Dairy Mart #6
Morgantown, WV
ID #3-103960
Inspected: October 20, 2003
Inspector: Clark S. Conover
EPA/RIII/Wheeling
Photo#: 3

This photo depicts the tank access points.

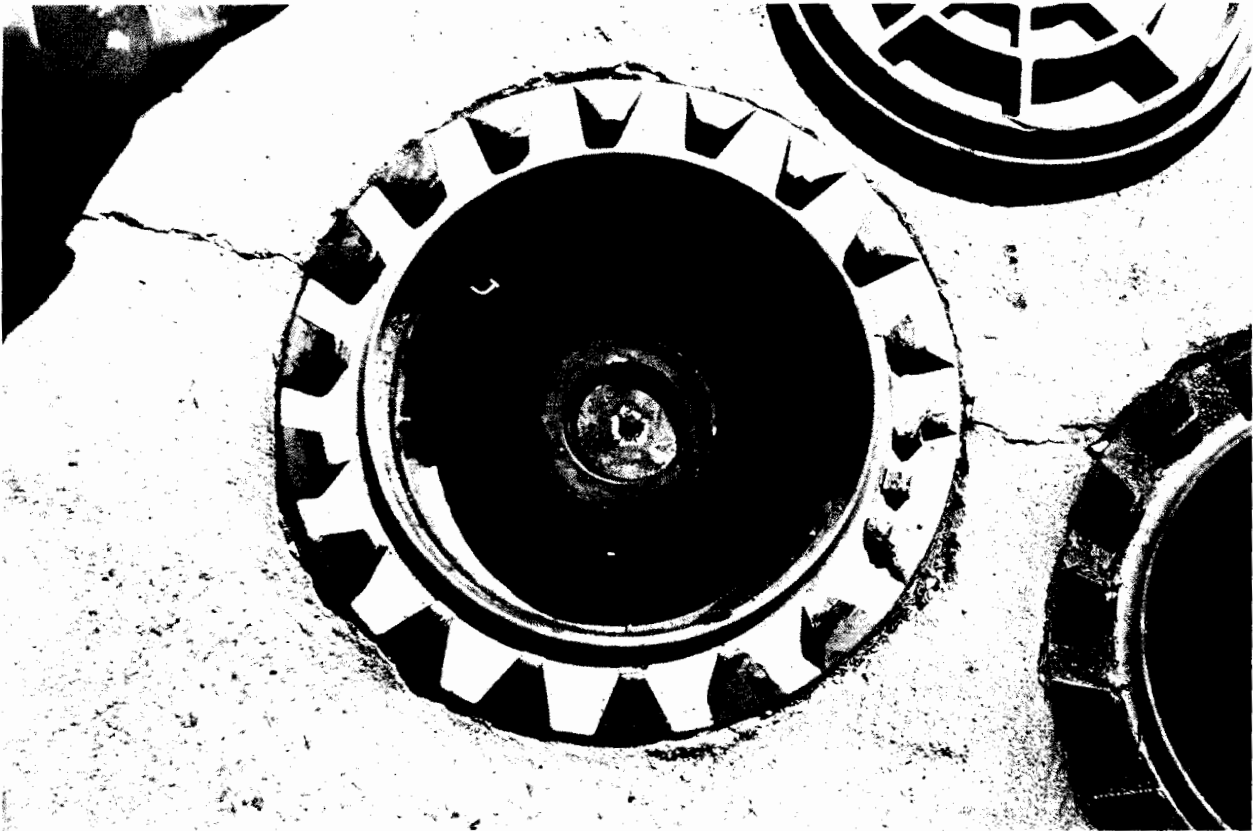
**Dairy Mart #6
Morgantown, WV
ID #3-103960
Inspected: October 20, 2003
Inspector: Clark S. Conover
EPA/RIII/Wheeling
Photo#: 6**

This photo depicts the vapor recovery point for compartment 1A.

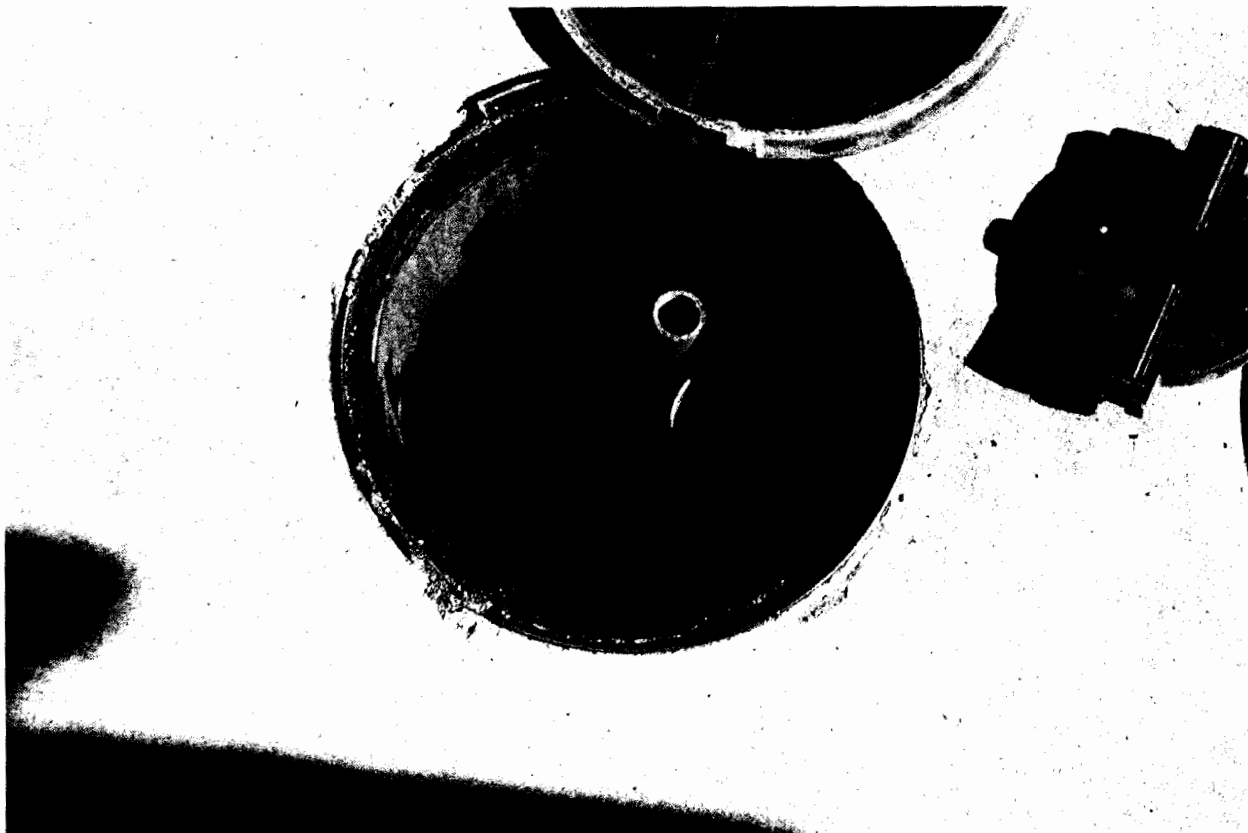
Dairy Mart #6
Morgantown, WV
ID #3-103960
Inspected: October 20, 2003
Inspector: Clark S. Conover
EPA/RIII/Wheeling
Photo#: 11

This photo depicts the interstitial monitoring pressure on tank #2.

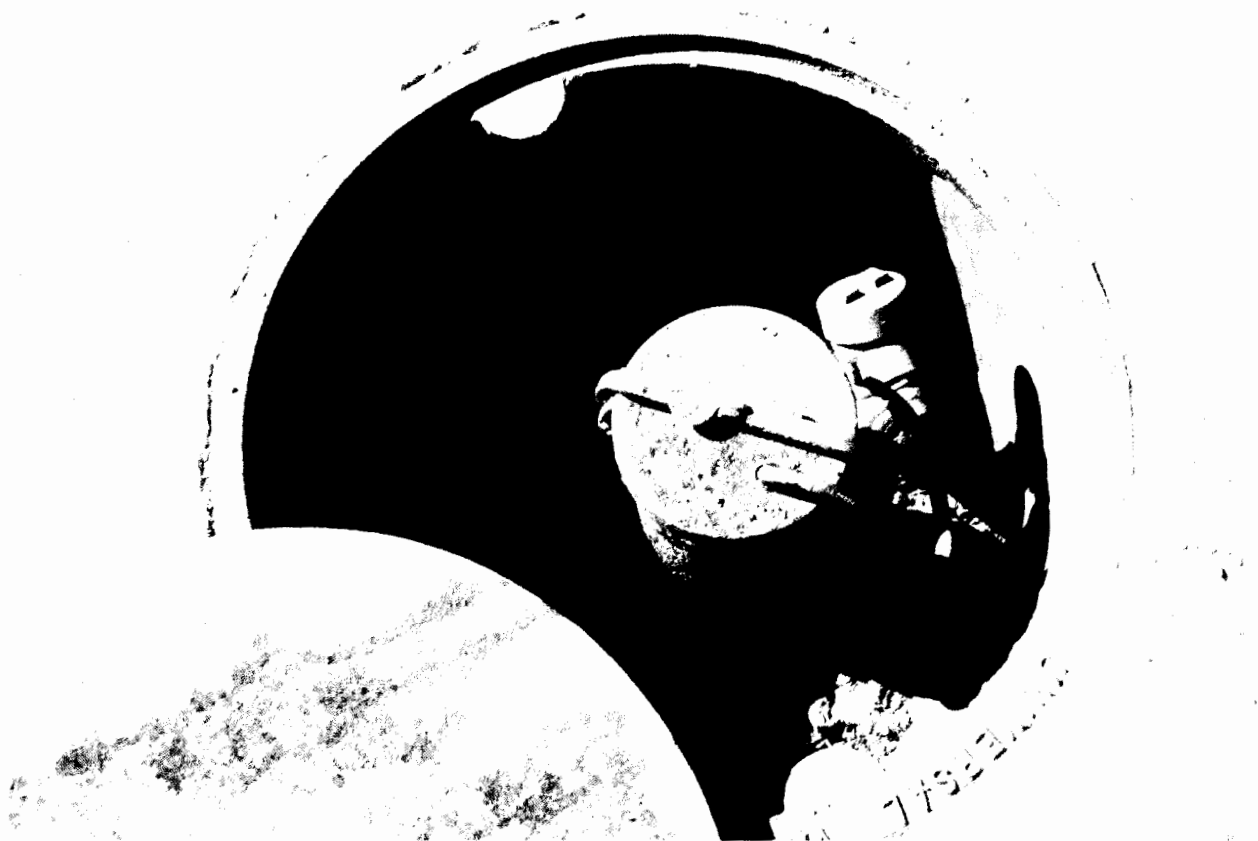
Dairy Mart #6
Morgantown, WV
ID #3-103960
Inspected: October 20, 2003
Inspector: Clark S. Conover
EPA/RIII/Wheeling
Photo#: 13

This photo depicts the ATG monitor in tank #2.

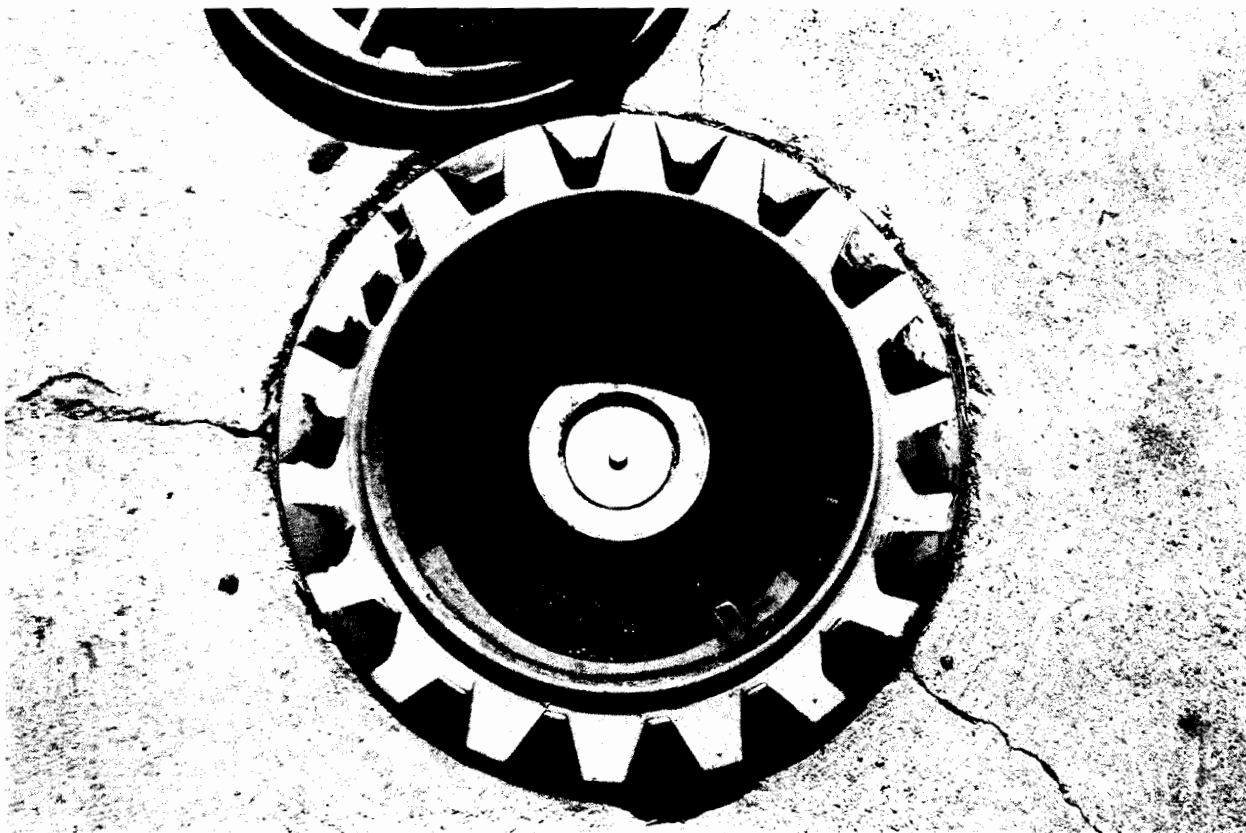
Dairy Mart #6
Morgantown, WV
ID #3-103960
Inspected: October 20, 2003
Inspector: Clark S. Conover
EPA/RIII/Wheeling
Photo#: 16

This photo depicts the vapor recovery point for compartment 1B.

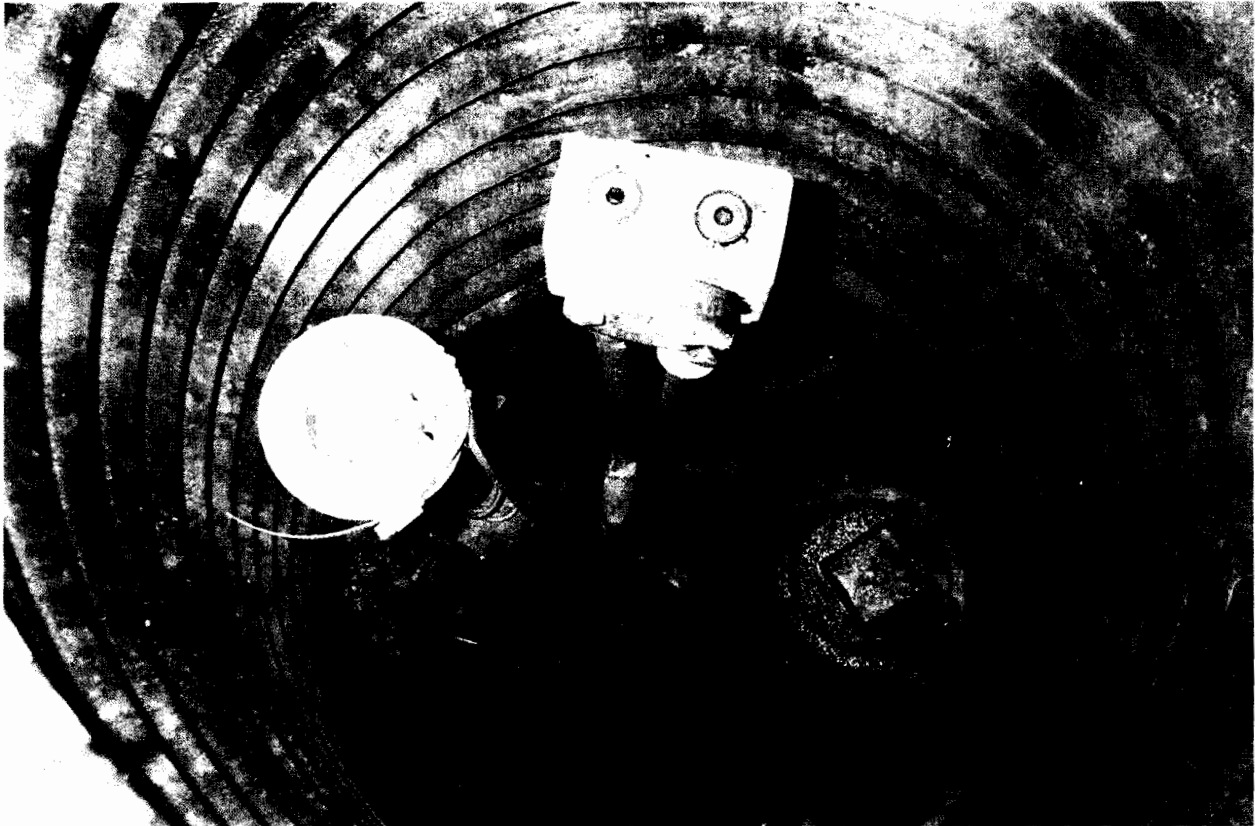
Dairy Mart #6
Morgantown, WV
ID #3-103960
Inspected: October 20, 2003
Inspector: Clark S. Conover
EPA/RIII/Wheeling
Photo#: 19

This photo depicts the interstitial vacuum on compartment 1B.

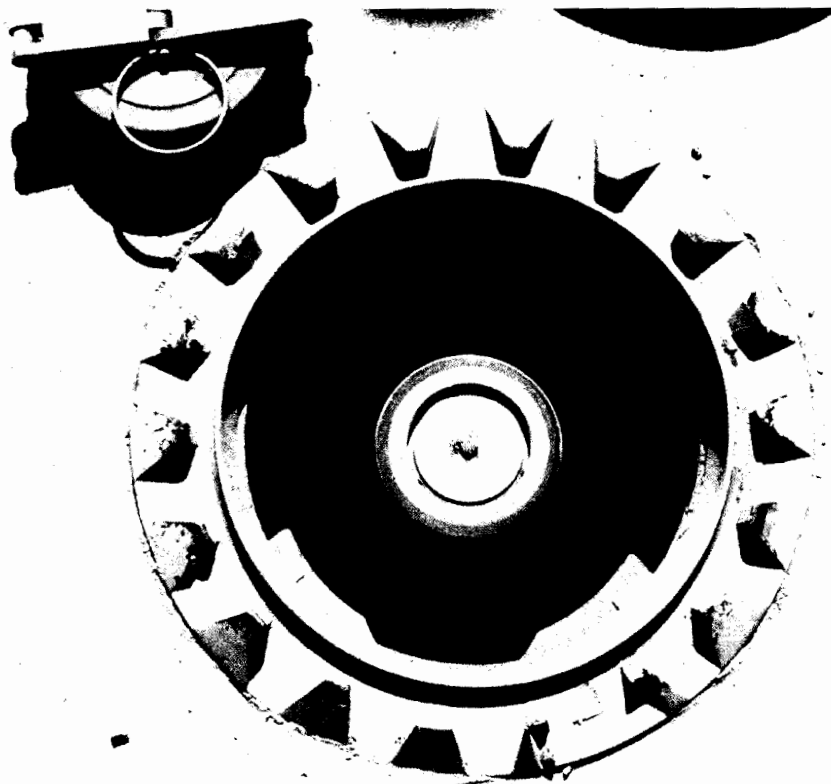
**Dairy Mart #6
Morgantown, WV
ID #3-103960
Inspected: October 20, 2003
Inspector: Clark S. Conover
EPA/RIII/Wheeling
Photo#: 22**

This photo depicts the vapor recovery on tank #3.

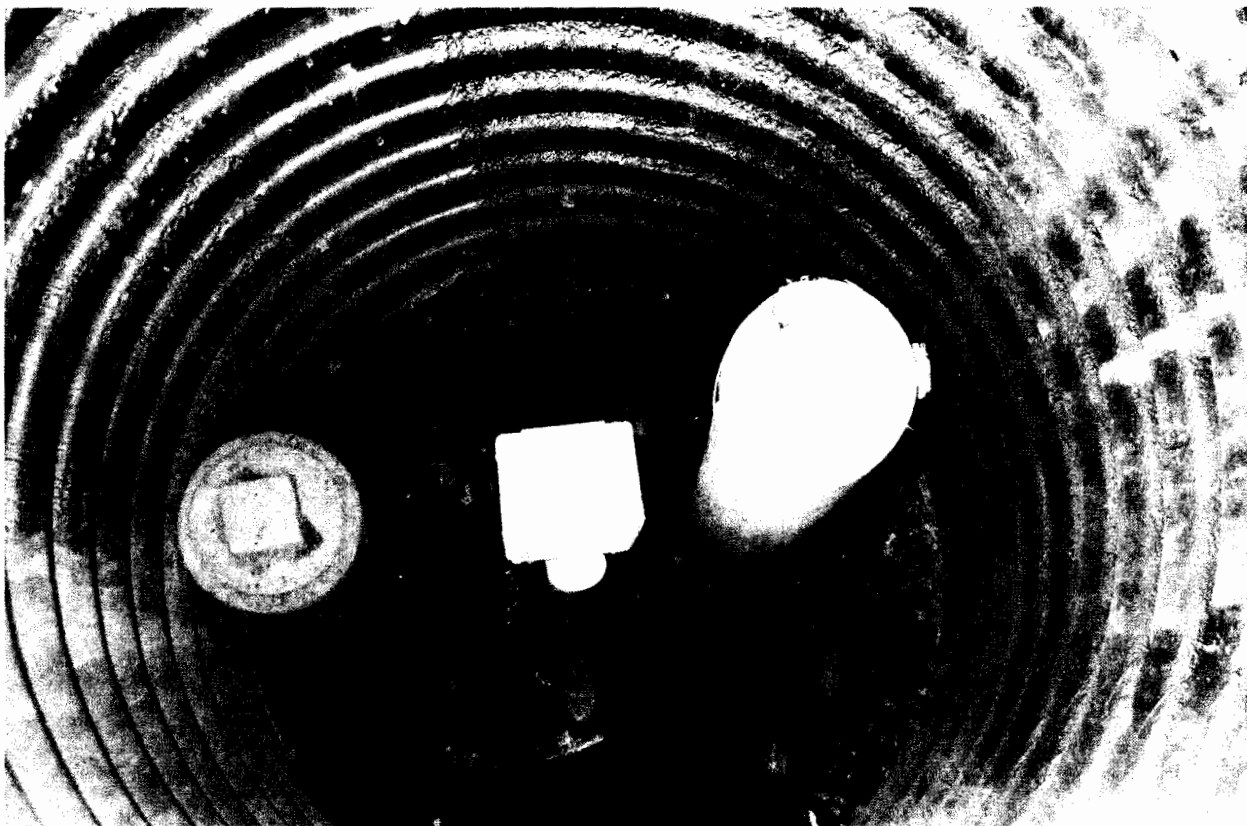
Dairy Mart #6
Morgantown, WV
ID #3-103960
Inspected: October 20, 2003
Inspector: Clark S. Conover
EPA/RIII/Wheeling
Photo#: 25

This photo depicts the interstitial vacuum gauge.

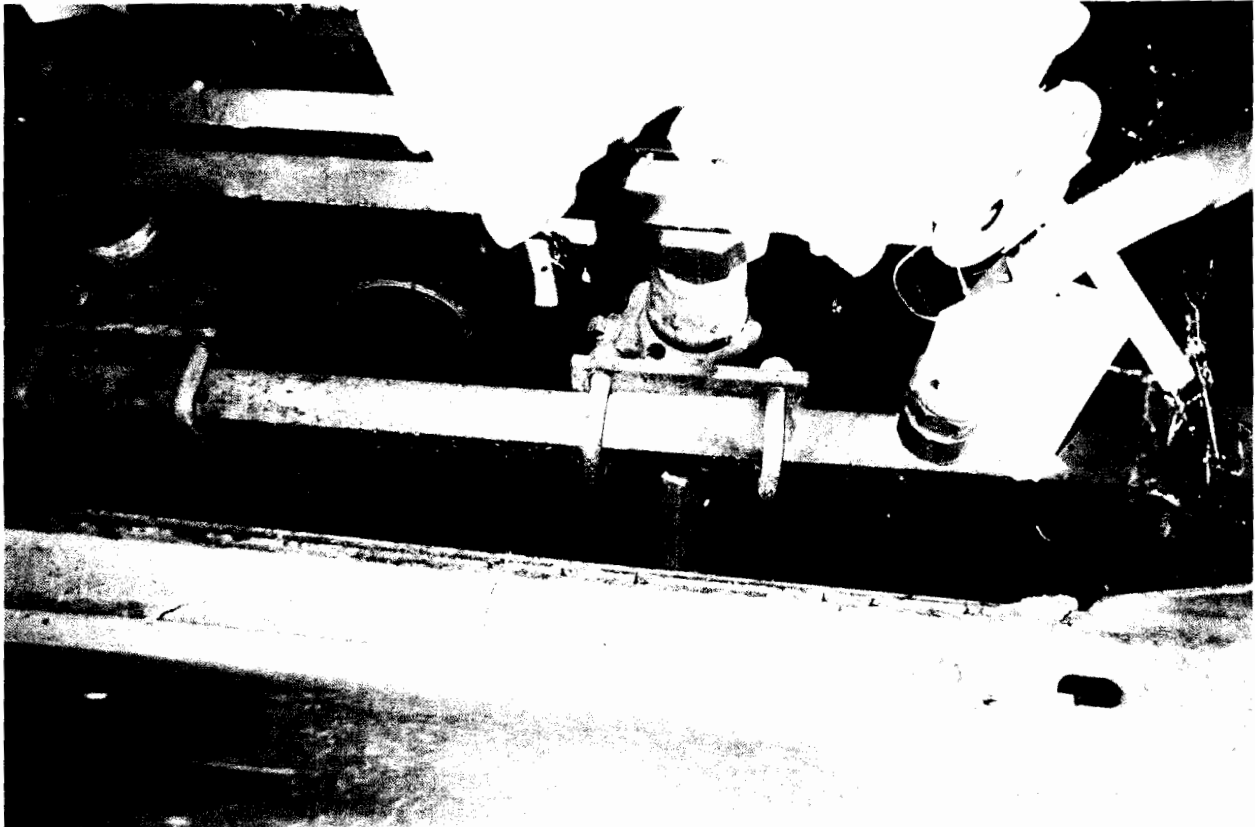
**Dairy Mart #6
Morgantown, WV
ID #3-103960
Inspected: October 20, 2003
Inspector: Clark S. Conover
EPA/RIII/Wheeling
Photo#: 26**

This photo depicts the area under the dispenser.
